SERVICE BULLETIN

BULLETIN NUMBER: 106

MODEL: DS5, DS7, W-7

SUBJECT: Sea Water Pump Weep Hole

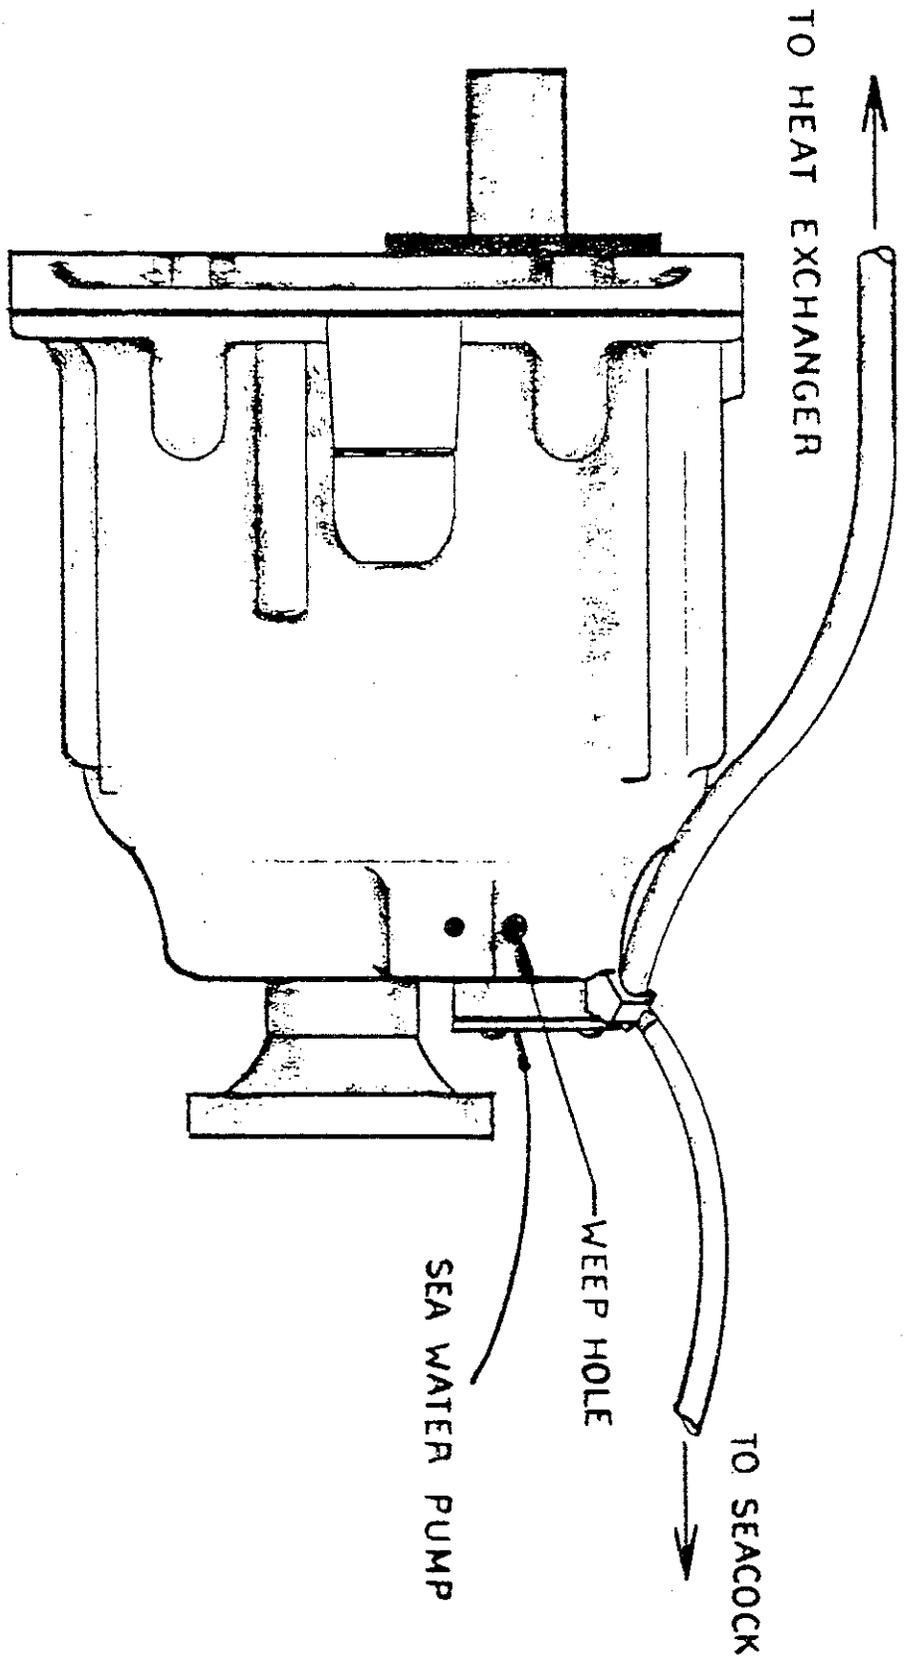
When performing daily engine checks, owners should pay particular attention to the weep holes just behind the sea water pump, which are visible on either side of the transmission. If there is any indication of sea water coming out of these weep holes, owners must remove the sea water pump and replace the seal (P.N. 16663) between the pump and the weep holes.

Failure to replace the seal when leakage is found at these weep holes will eventually lead to sea water entering the transmission.

Note: Leakage from these weep holes can also be caused by a blockage in the sea water flow through the engine or heat exchanger cooling circuit.

Ensure that these weep holes are not obstructed in any way by rust or scale build-up.
