SERVICE BULLETIN

BULLETIN NUMBER: 264

SUBJECT: High Tension Coil Wire

MODELS: 5.0/4.2SBCG and 6.5/5.4SBCG LOW CO Gasoline Generators

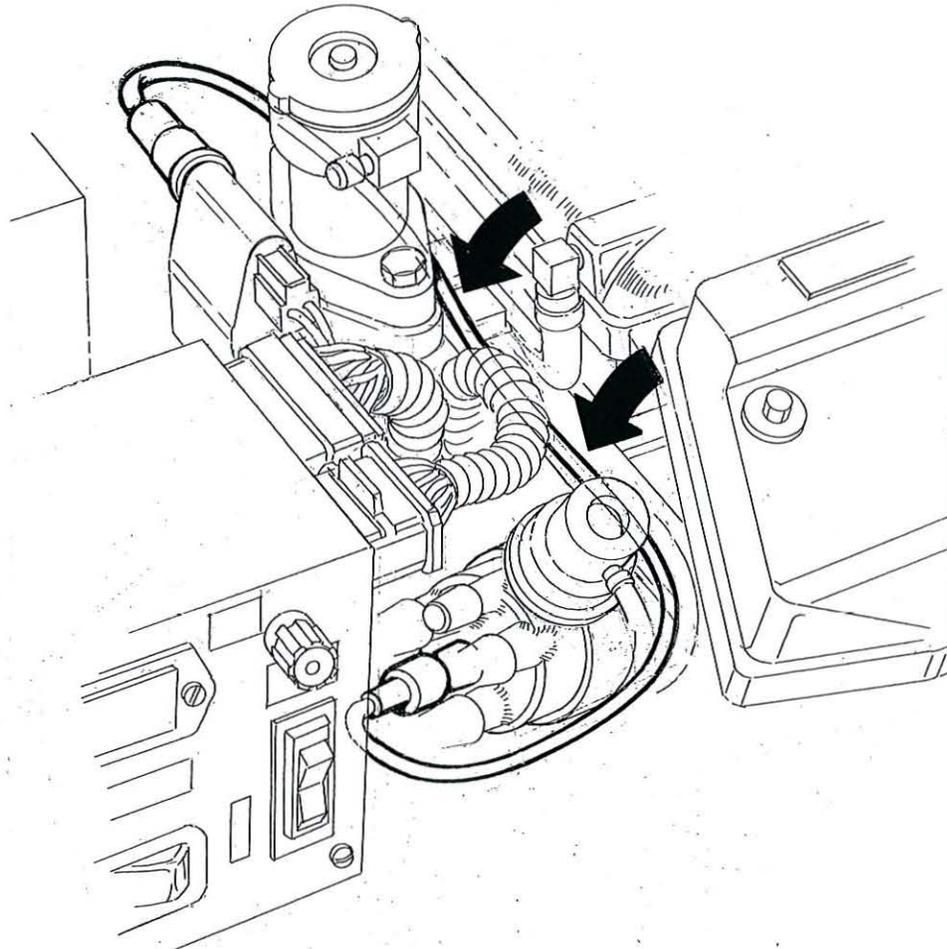
DETAIL: Issues have been found in the field related to the routing of the High Tension Coil Wire.

High tension coil wires have been found routed over and lying on the DC engine harness going into the units control box. EMI (electromagnetic interference) on the DC engine harness has been responsible for engine operating issues such as erratic engine operation, hunting and engine over speeds.

The illustration below shows the correct routing of this coil wire in order to position it away from the engine's DC harness. This wire must be routed out of the coil and behind the thermostat housing, then along the cylinder head area, under the distributor assembly and into the connection on the distributor cap.
