# SERVICE BULLETIN

**BULLETIN NUMBER:** 259

**SUBJECT:** Drive Belt Tension

3.0 BPMG-612

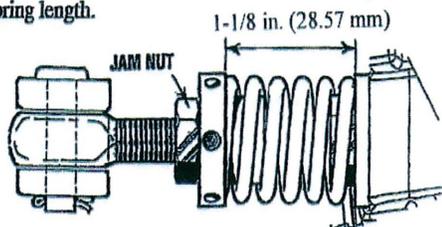
**DETAIL:** The generator drive belt tension specification as shown/illustrated in the Operator's Manual publication #048009 is in error. It does not coincide with our engineering design and the actual adjustment being set by our manufacturing department. The adjustment specification of 1-1/4 inches (31.79mm) should be 1-1/8 inches (28.57mm).

The belt tension can be checked by measuring the spring length.
