SERVICE BULLETIN

BULLETIN NUMBER: 2023-1

SUBJECT: 56919 Dipstick

AFFECTED: 9.5 MCGA, Manufacturing Date Code “WC” (March 2023) and Prior

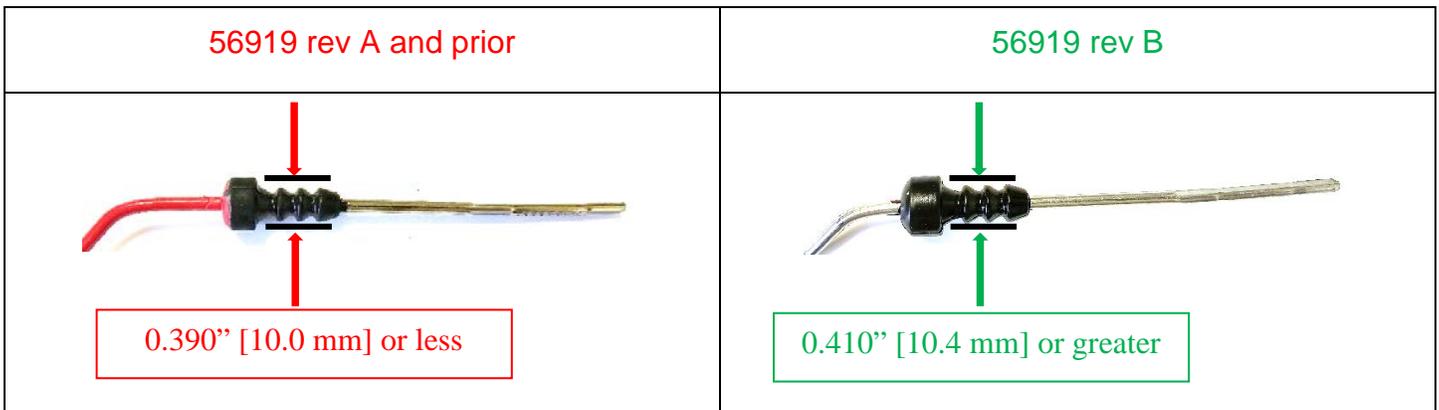
There have been reports from the field of dipsticks on some 9.5 MCGA generators in the subject date codes not fitting as snugly as expected in the engine block. Some of these dipstick seals have been reported to not remain fully seated and potentially weep oil under certain operational and environmental conditions. A revised dipstick grommet has been developed and put into production. The rubber has been reformulated and the dimensions of the grommet have been increased to provide a tighter seal in the engine block. Dipsticks that have shipped from the factory after March 17, 2023 are the latest rev B design. Dipsticks from dealer inventory or shipped from the factory prior to that date may or may not be the latest revision. To determine whether a particular dipstick is the latest revision, measure the grommet diameter as shown below. The measurements shown are with the calipers very lightly in contact with the grommet, not squeezing it. Measure at 2 points 90 degrees from each other and average the result. If there is any uncertainty about which revision a particular dipstick is, replace it with a known new style dipstick.

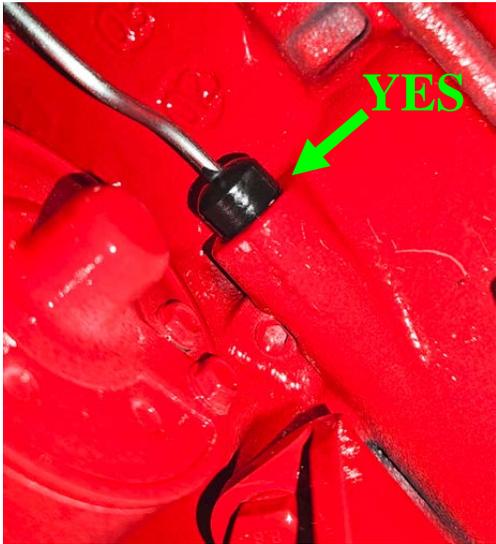
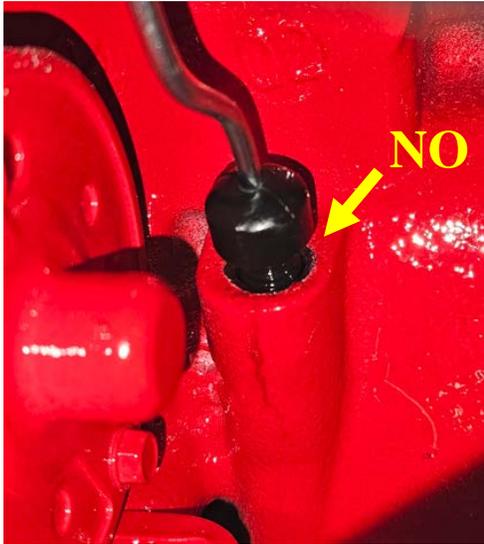
FULLY INSERTED DIPSTICK (CORRECT)	PARTIALLY INSERTED DIPSTICK (INCORRECT)

The improved dipstick design fits very snugly in the engine block to ensure a tight, vibration-resistant seal. Reports from the field indicate that some inexperienced operators might install the new style dipstick incorrectly by failing to insert it fully into the hole. This could potentially result in the dipstick coming out of the hole during engine operation. A brand-new dipstick grommet should be lubricated with engine oil before the first insertion to allow the grommet to slip more easily into the fully seated position. It is important that the dipstick be FULLY and completely inserted into the engine block for proper oil level indication and for optimal sealing. Please refer to the following photographs for more information:

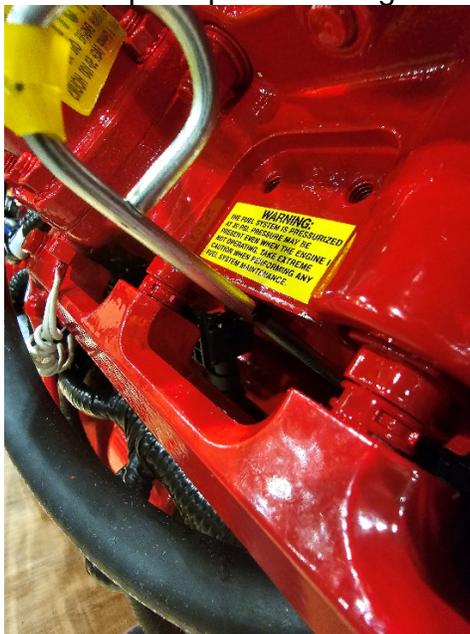
Proper dipstick routing:

Improperly routing the dipstick by forcing it under the intake manifold can result in a bent dipstick and can cause the dipstick to rub against rotating internal engine components. Improper routing can also result in the grommet being damaged and failing to seal properly.

It has also been reported that some operators have failed to route the dipstick in the correct location. The dipstick must be routed through the space between the intake manifold and the fuel rail. The dipstick must be inserted part way past the manifold then rotated 90 degrees as the grommet is fully inserted to fit properly.
